# Concrete Repair

A practical guide

Edited by Michael G. Grantham

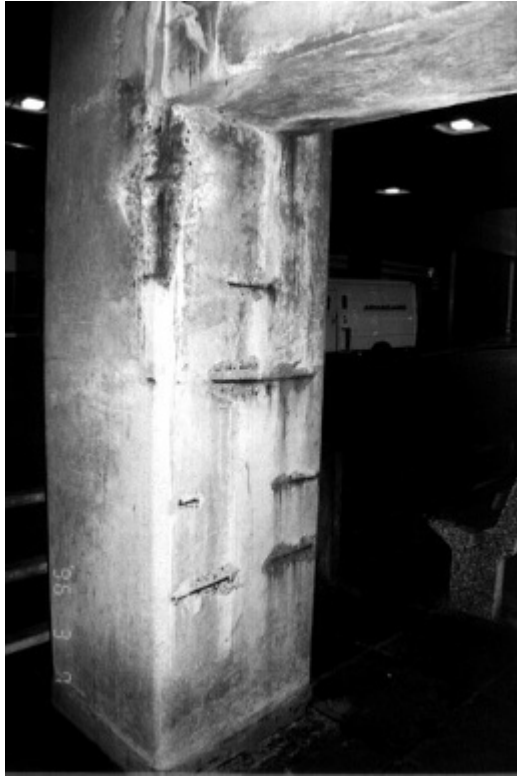
*Figure 1.1* Zero cover provided to a column in a reinforced concrete car park.

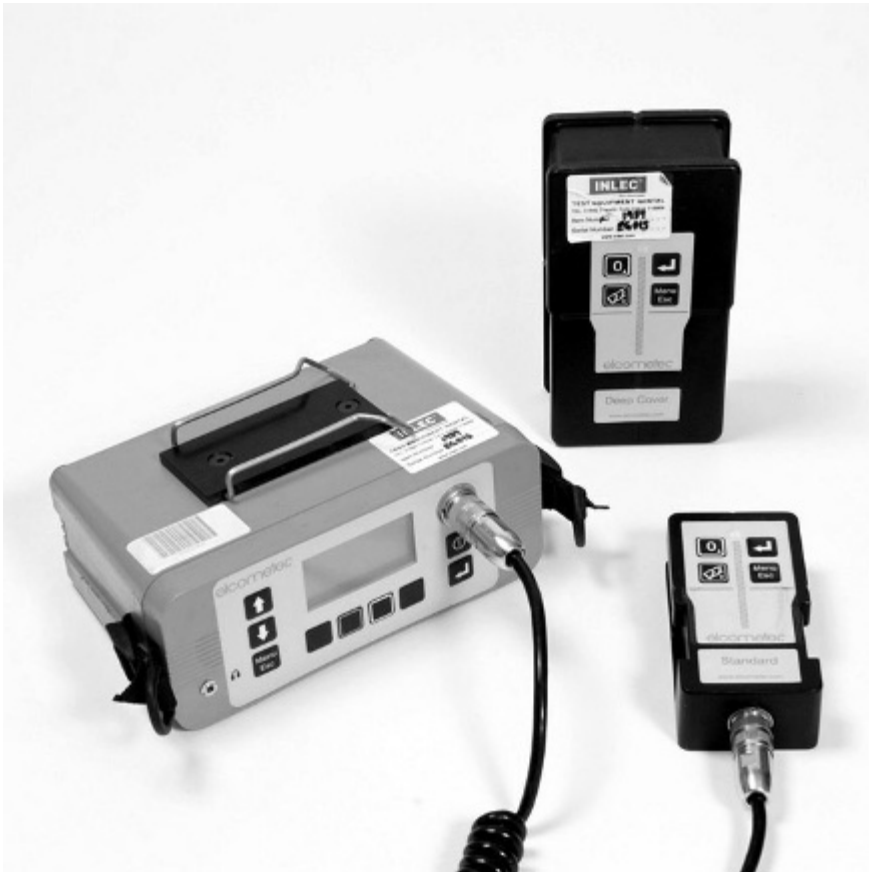
Figure 1.3 Elcometer 331S covermeter (courtesy Elcometer Ltd).

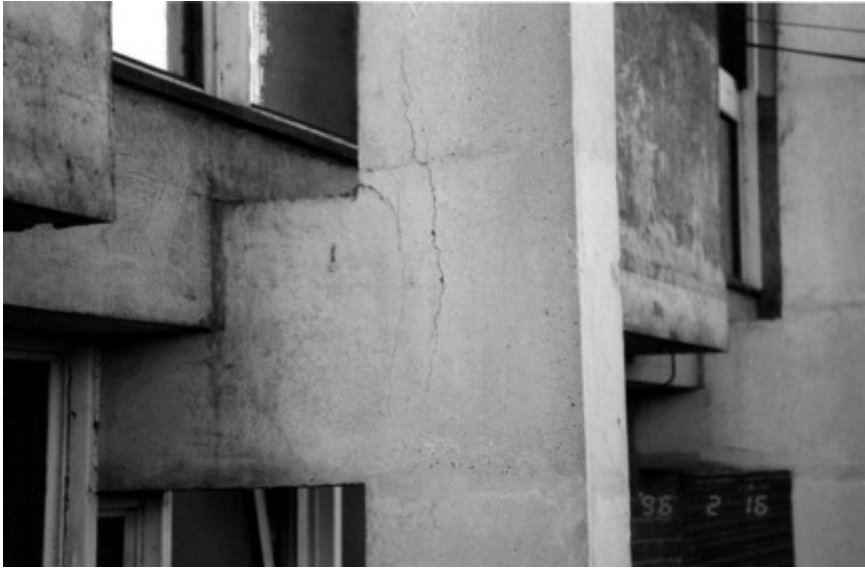
Figure 1.4 Structural cracks in a column due to overloading/inadequate reinforcement.

Actual structural failure, or even structural cracking, is only rarely encountered but it is important to differentiate between cracking from structural and other causes. Such an assessment should only be carried out by a structural engineer. Figure 1.4 illustrates structural cracks at a column/beam connection. If examined carefully, the column behind shows no evidence of cracking, but in this case the beam is supported on a brick wall. The wall was not intended to be load bearing, but was clearly taking some of the stress off the column.

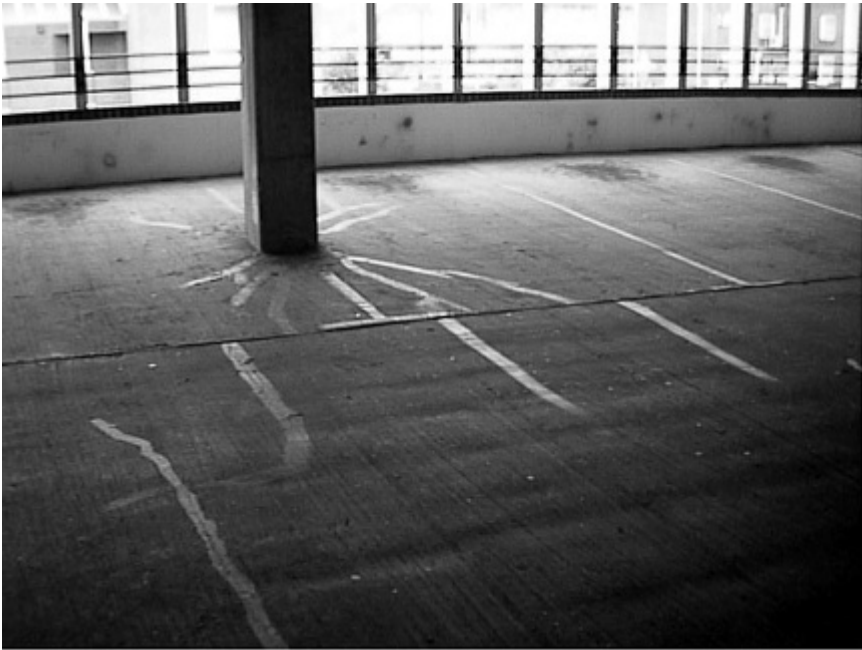
*Figure 1.5* Cracks due to the onset of punching shear in a car park deck slab.

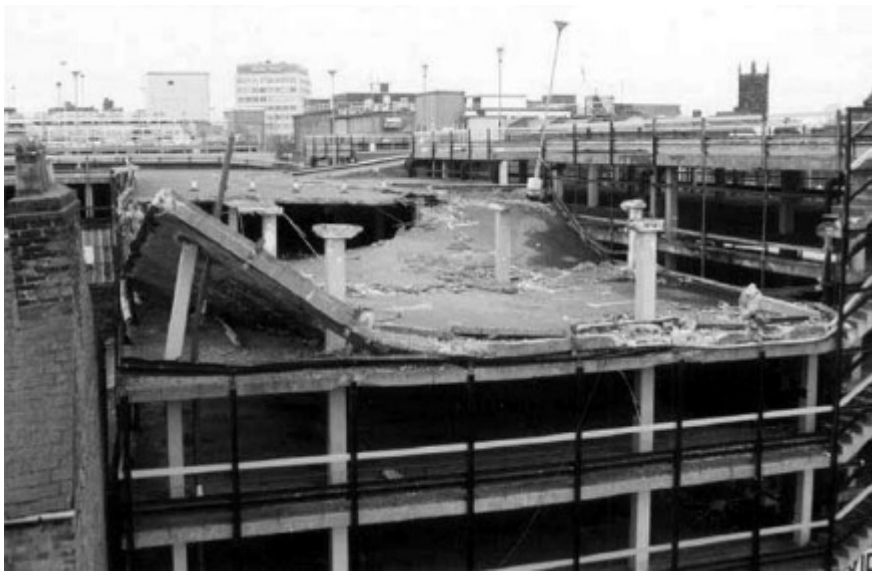
*Figure 1.6* Pipers Row car park in Wolverhampton, after failure (photo courtesy of HSE).

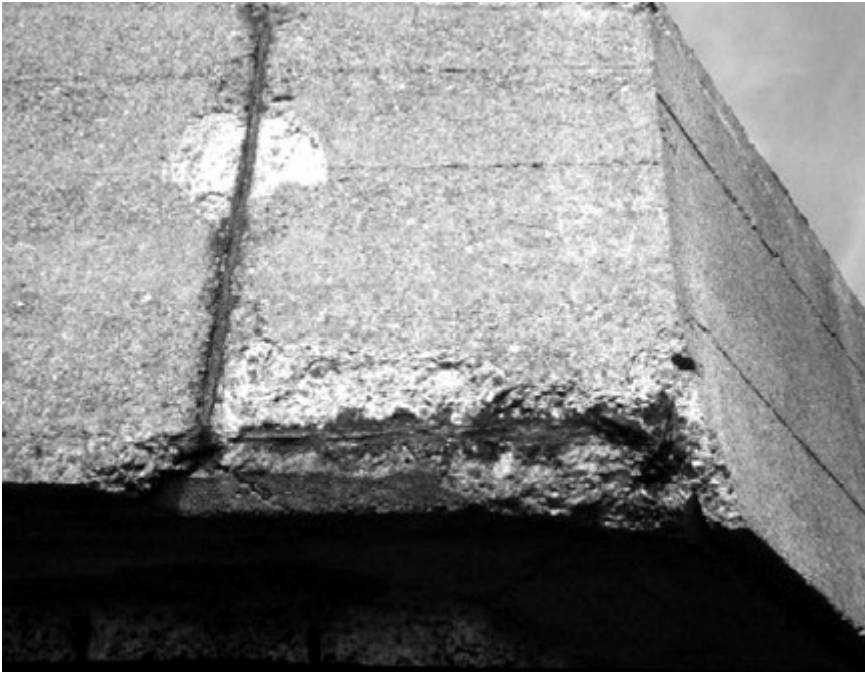
*Figure 1.7* Low cover and carbonation induced corrosion.

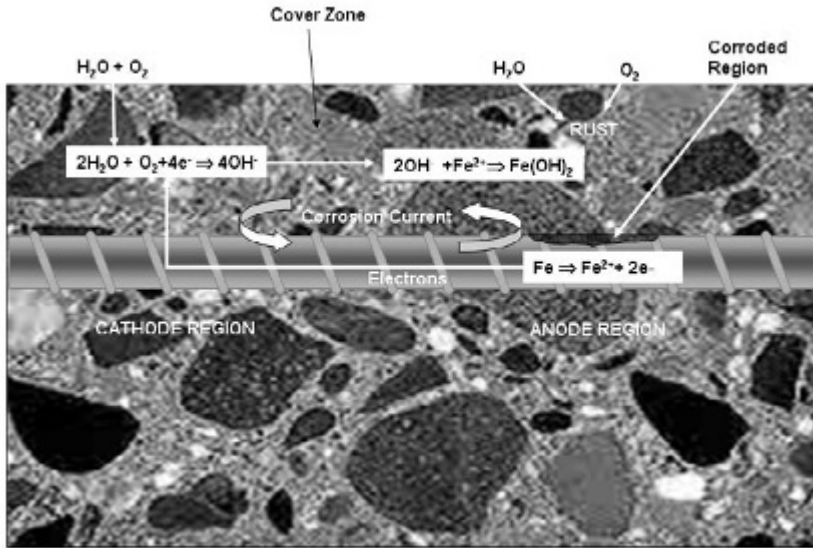
Figure 1.8 Schematic showing mechanism of corrosion in reinforced concrete.

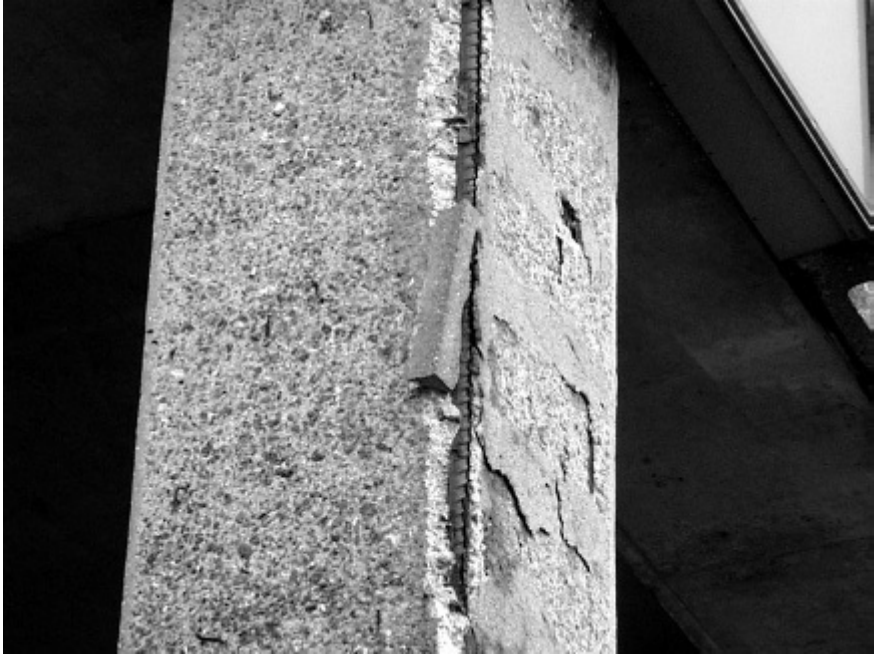
Figure 1.9 Carbonation and chloride-induced damage on a seafront structure.

Figure 1.9 illustrates corrosion caused by both carbonation and ingress of wind-blown marine salt to an office structure near to the sea. Interestingly, we had surveyed the same structure three years previously, and only splitting of the columns was apparent. In three years the damage had progressed to become a public safety matter, and was verging on causing structural problems.

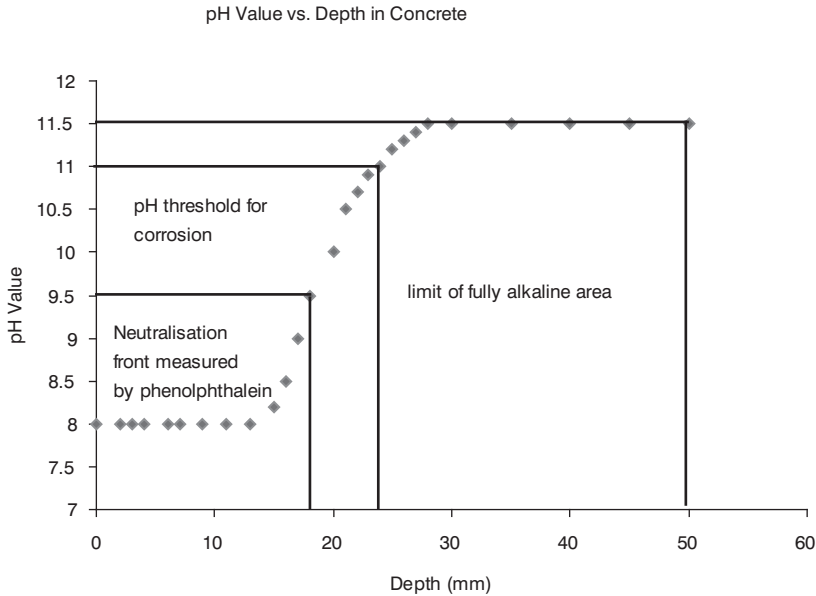
Figure 1.10 Graph showing variation of pH with depth (from Broomfield, 2007).

There is a lot more calcium hydroxide in the concrete pores than can be dissolved in the pore water. This helps maintain the pH at a high level as the carbonation reaction occurs. However, eventually all the locally available calcium hydroxide reacts, precipitating the calcium carbonate and allowing the pH to fall to a level where steel will corrode. This is illustrated in Figure 1.10.

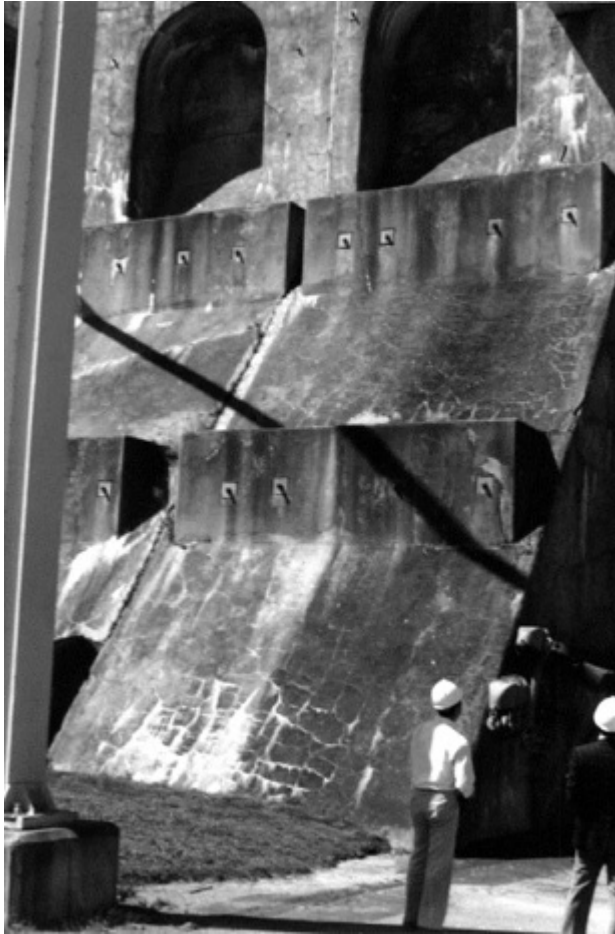
Figure 1.11 ASR-induced cracking on a dam in Canada.

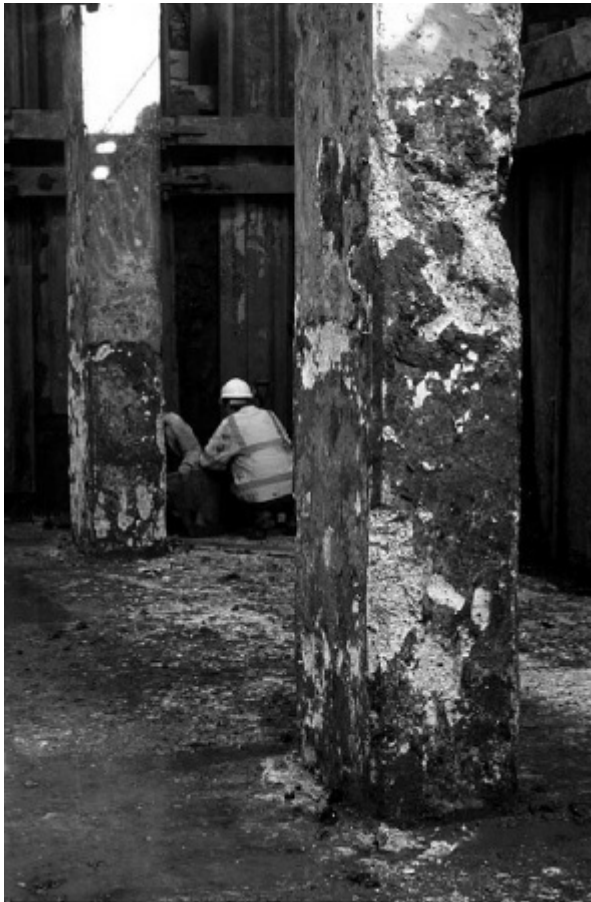
*Figure 1.14* Example of thaumasite/ettringite attack (courtesy of Halcrow plc).

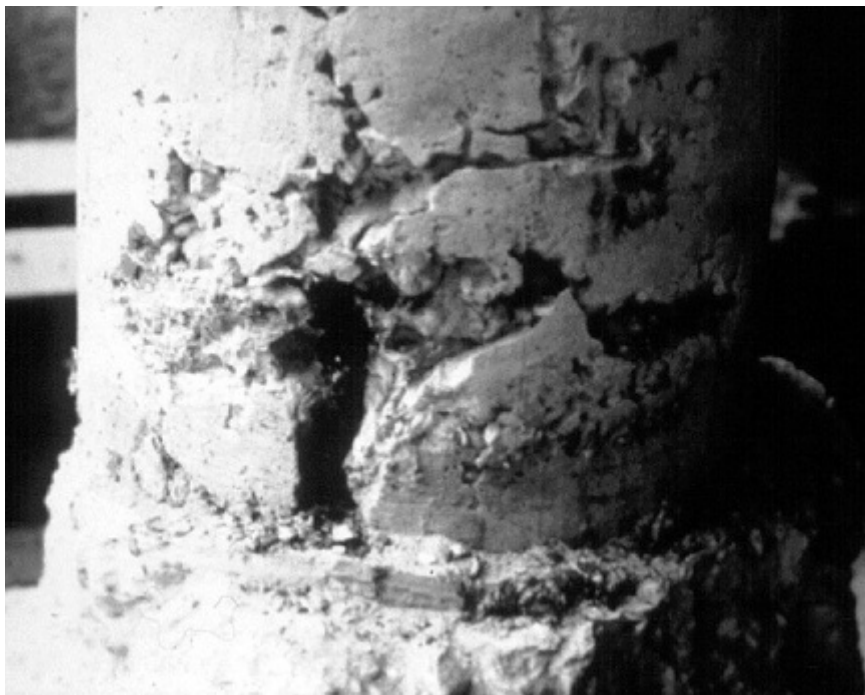
Figure 1.15 Poor compaction around the base of a pile.

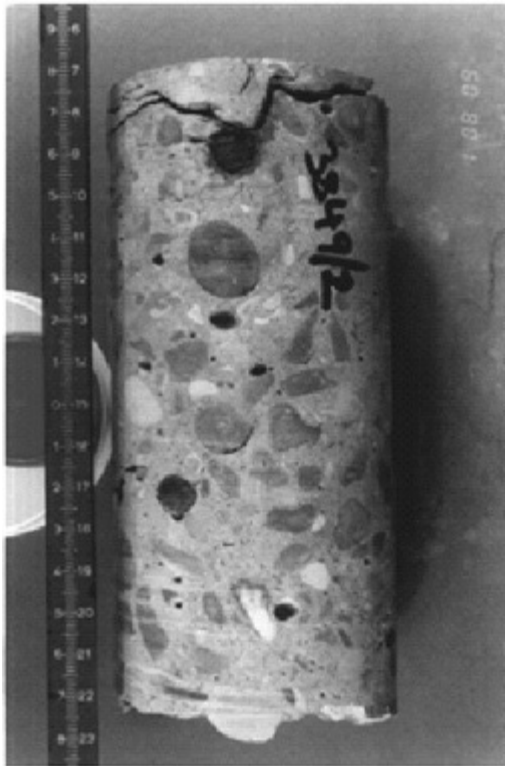
*Figure 1.16* Plastic settlement cracks in a core.

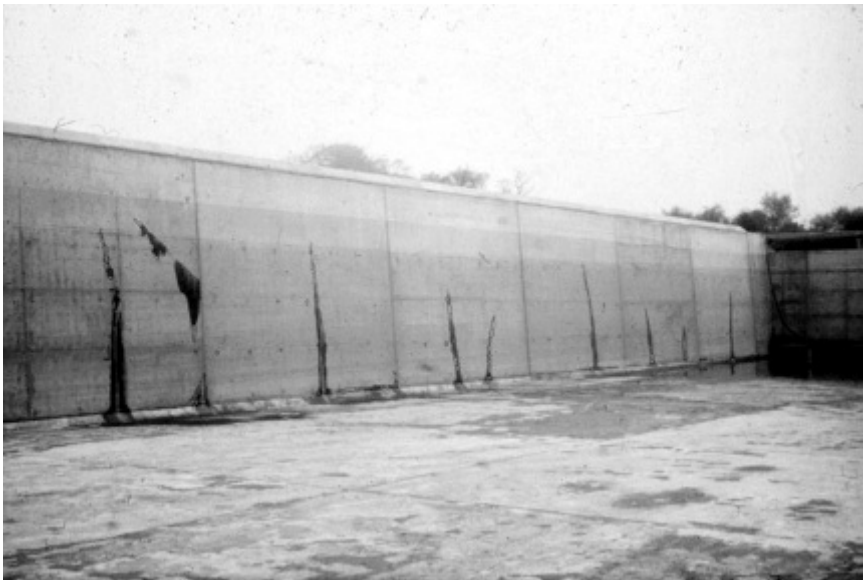
*Figure 1.17* Thermal cracks in the wall of a water tank.

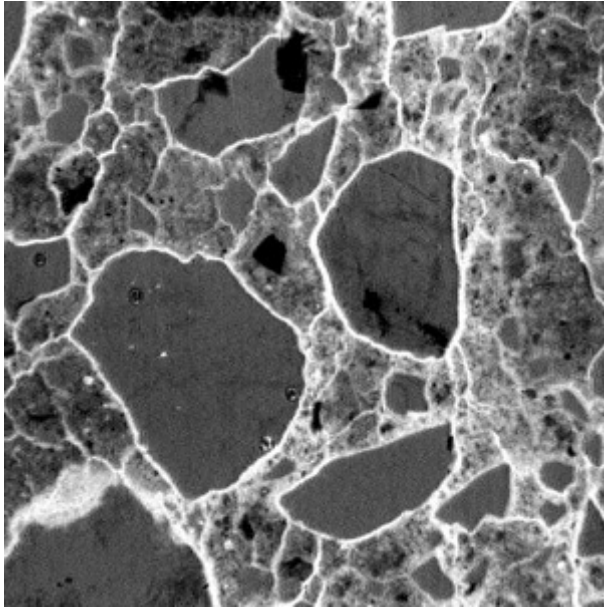
*Figure 1.18* Cracking in the cement paste due to delayed ettringite formation. In this case, the cement paste expands, rather than the aggregate crack.

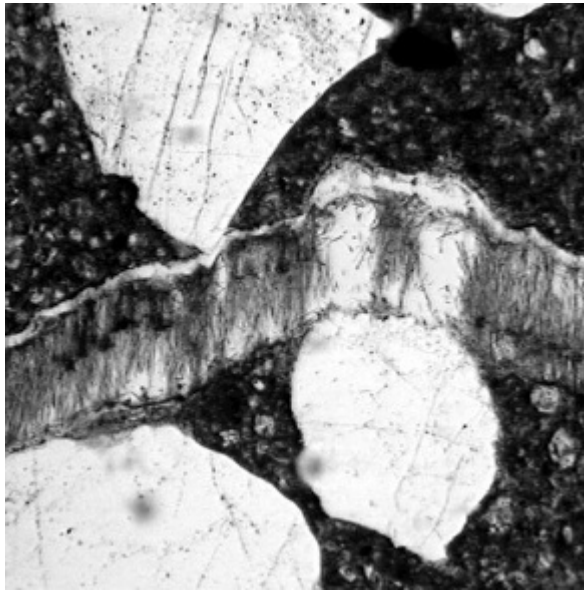
*Figure 1.19* Ettringite crystals lining a crack.

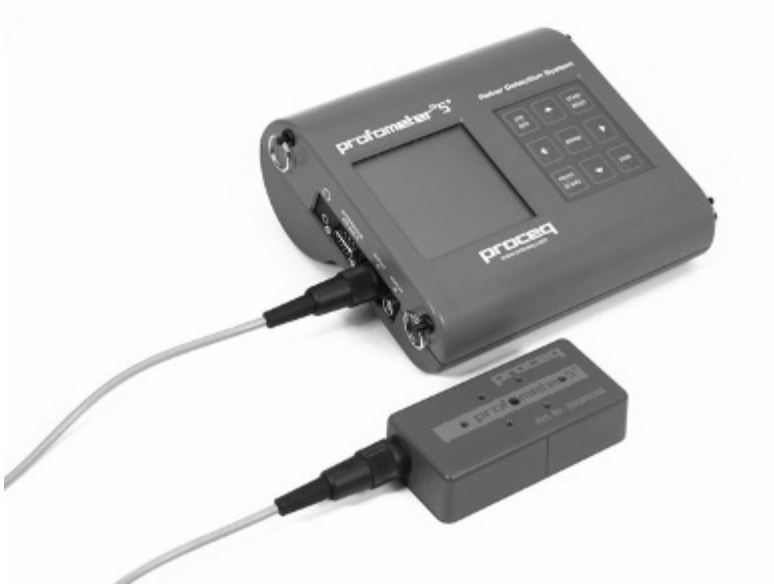
Figure 1.20 Proceq Profometer 5 covermeter (courtesy Proceq Ltd).

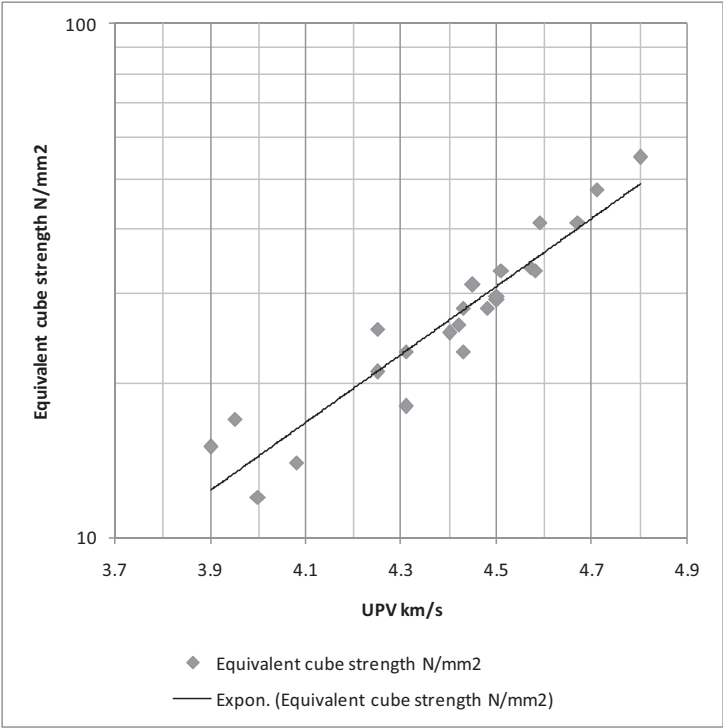
Figure 1.23 Typical relationship between cube strength and UPV.

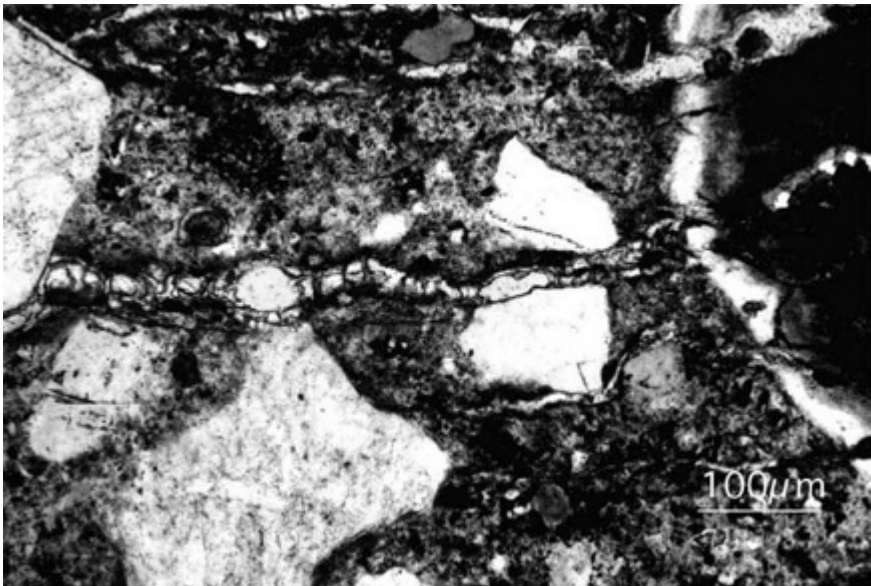
*Figure 1.25* Gel-filled cracks in concrete suffering from ASR, thin section.

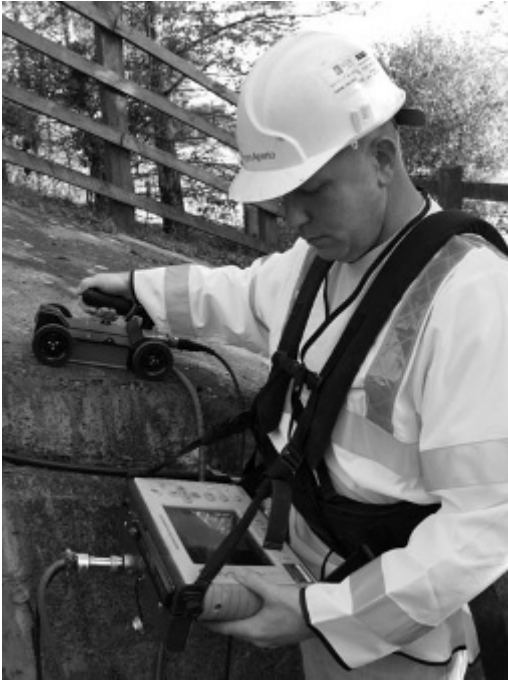
*Figure 1.27* Radar in use on a concrete investigation (Courtesy Fugro Aperio Ltd.).

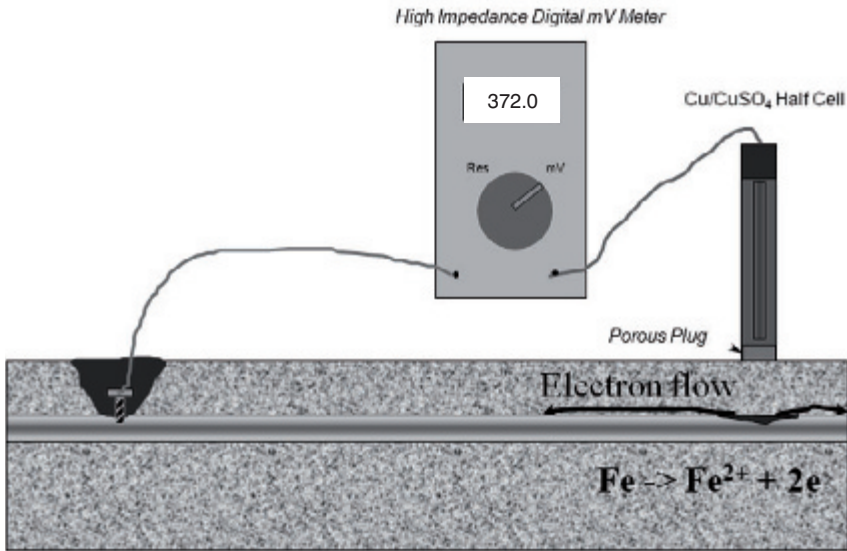
Figure 1.32 Half cell potential testing – schematic.

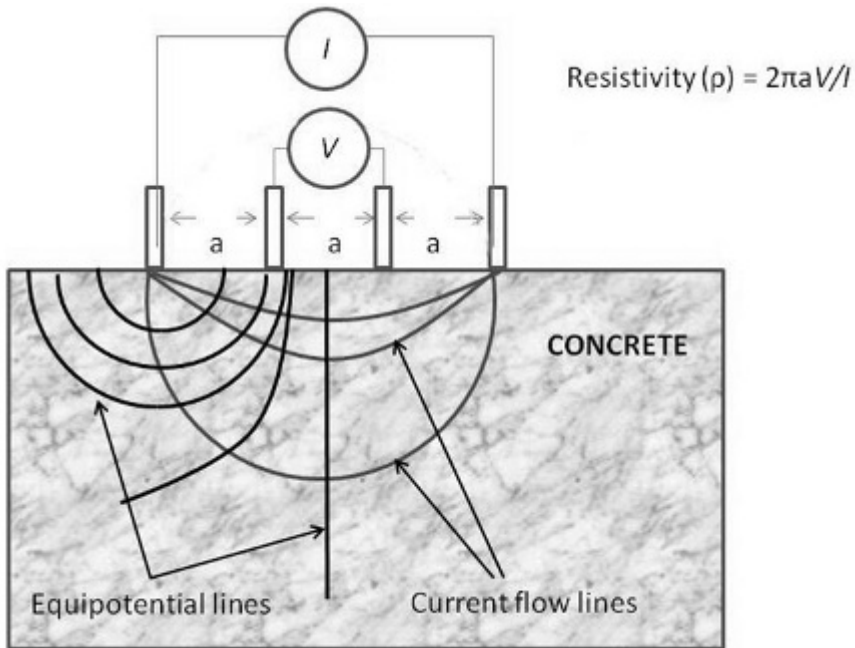
Figure 1.34 Schematic showing typical 4-probe resistivity measurement.

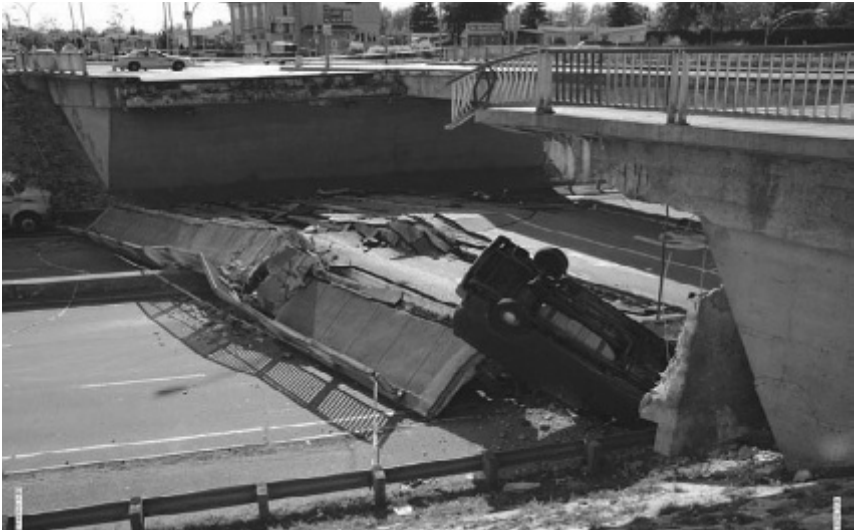
*Figure 3.1* De la Concorde overpass after collapse, five dead. The deteriorated badly repaired half joint and lower part of the cantilever can be seen hanging down.

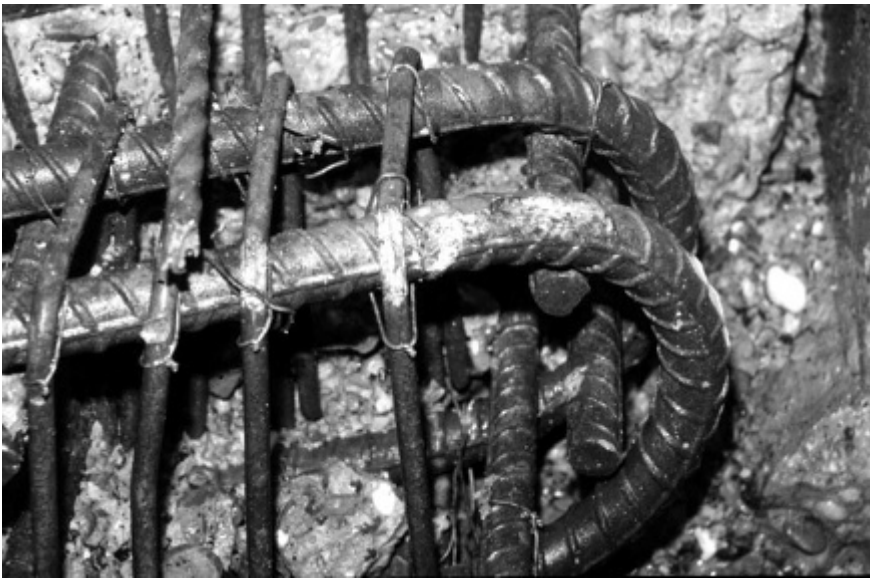
*Figure 3.4* Local pitting corrosion of links in a half joint, from chlorides in saturated concrete.

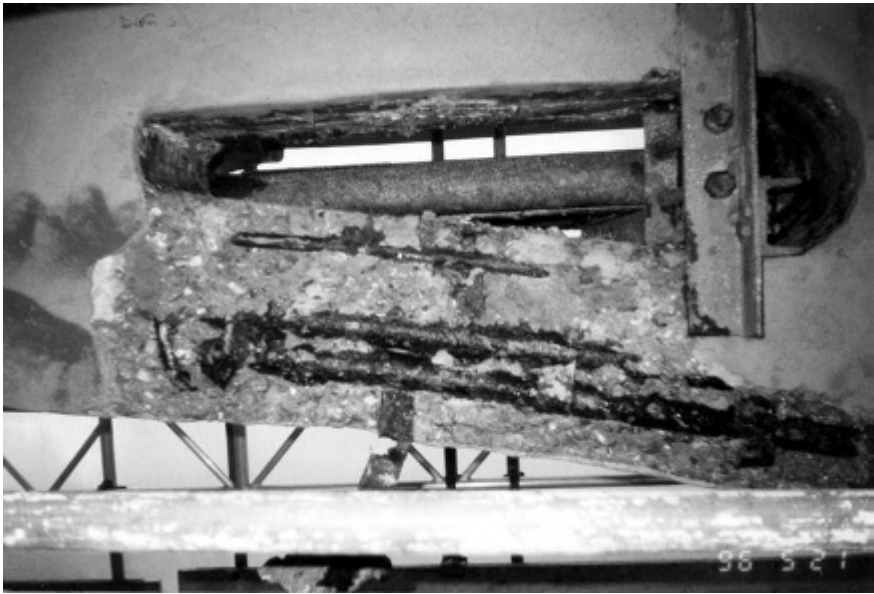
*Figure 3.5* Structurally damaging corrosion which will be substantially increased by cutting out to clear chlorides.

Effective repair requires cutting out to a sound substrate and to clear all carbonated and chloride contaminated material around the reinforcement (Figure 3.5). This cutting out inevitably further weakens the structure and the effects of this must be evaluated before the contract is let, including the potential consequences of more extensive cutting out, if that is found to be necessary as work progresses.

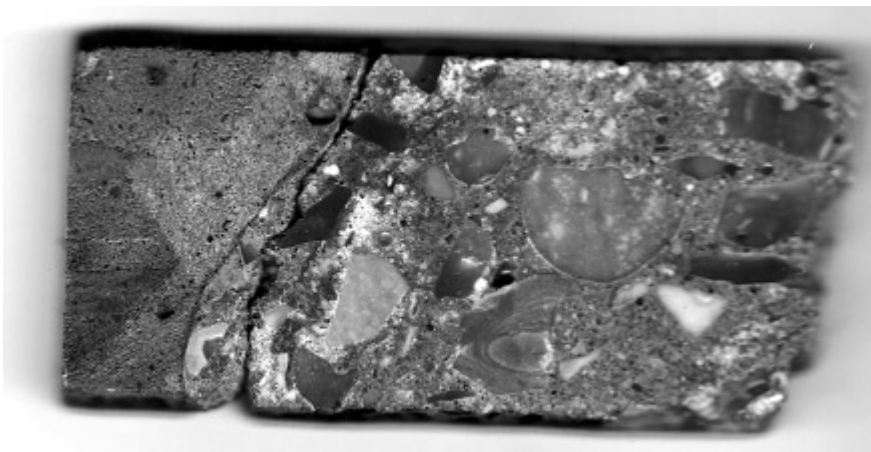
Figure 3.6 Weakened concrete bruised by a jack hammer – where the failures occur.

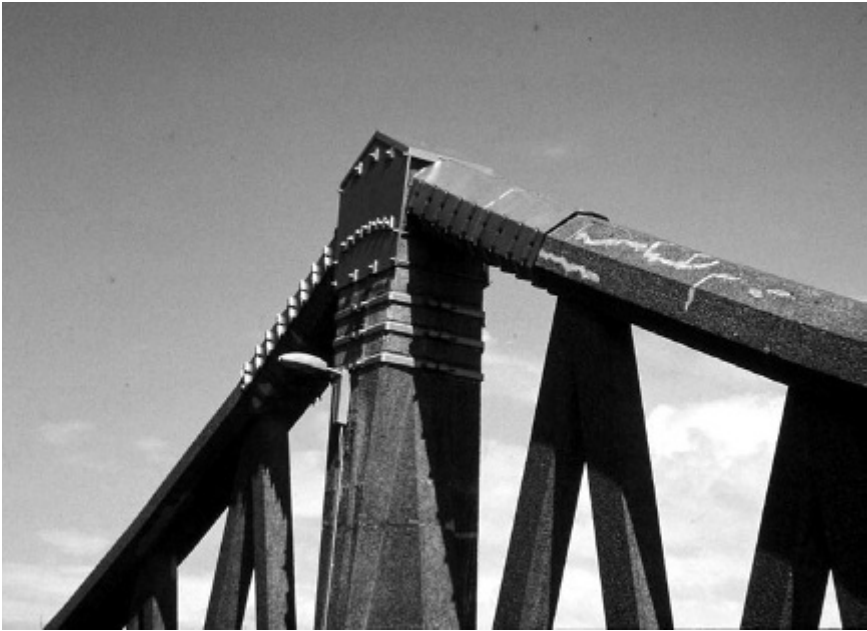
*Figure 3.8* Through bolting and clamping of splitting bridge tower head with AAR and deficient designed containment reinforcement.

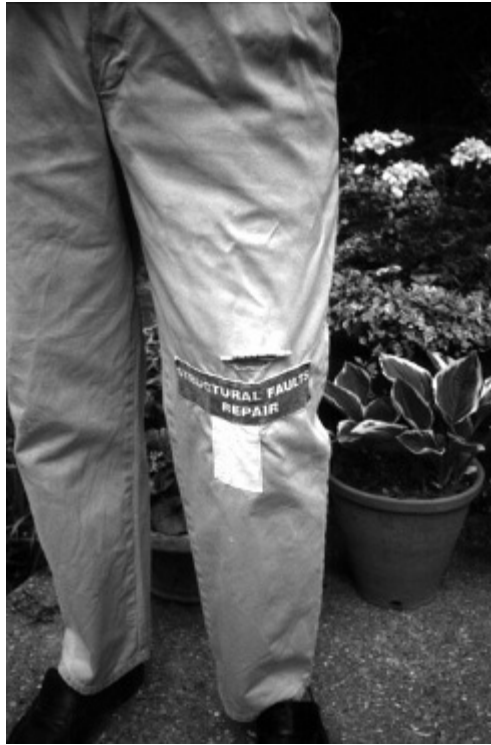
Figure 3.9 Differential shrinkage.

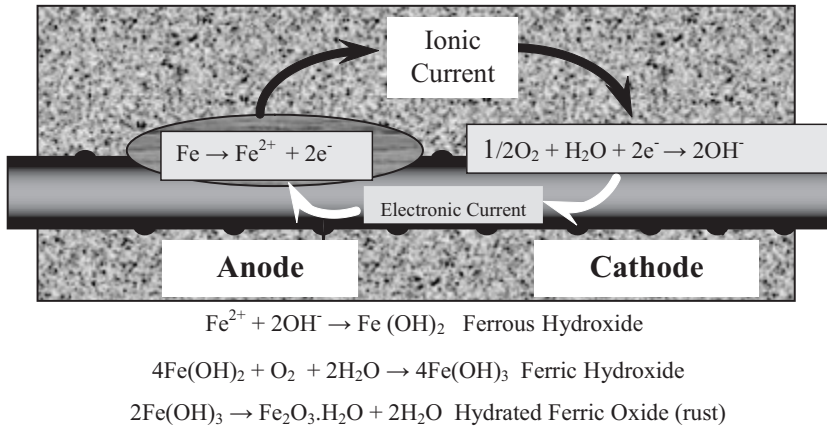
Figure 4.1 The anodic, cathodic and iron hydration reactions for corroding steel.

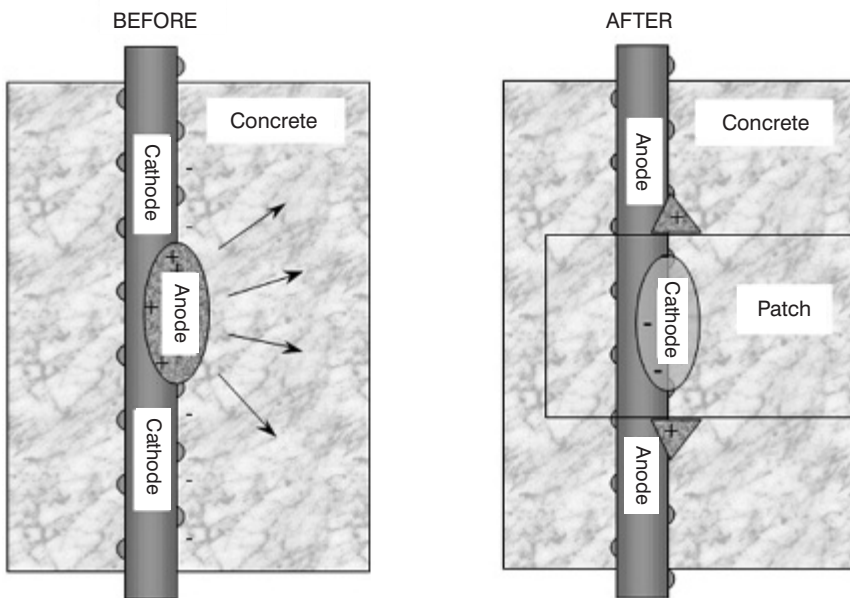
Figure 4.3 Incipient anode schematic showing how the anode is displaced to the edge of the repair by the formation of a new cathode in the patch repair (from Broomfield 2007).

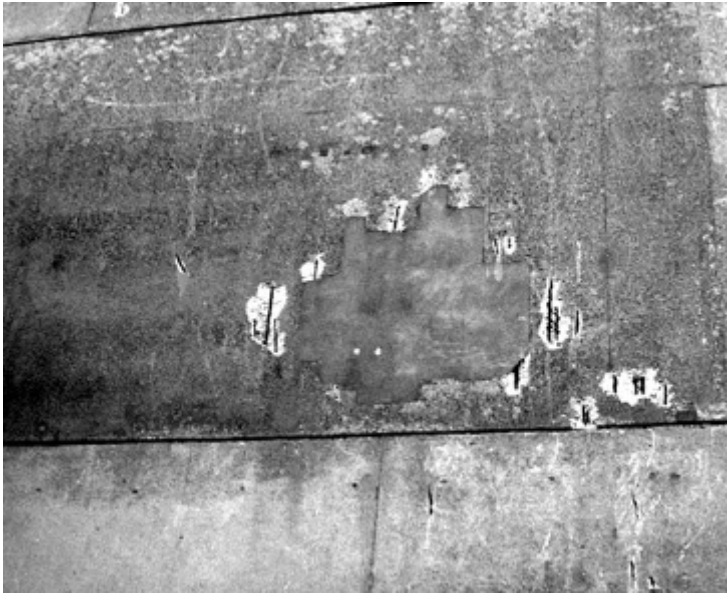
*Figure 4.4a* Patch repair with surrounding spalling due to incipient anodes on a building (from Broomfield 2007).

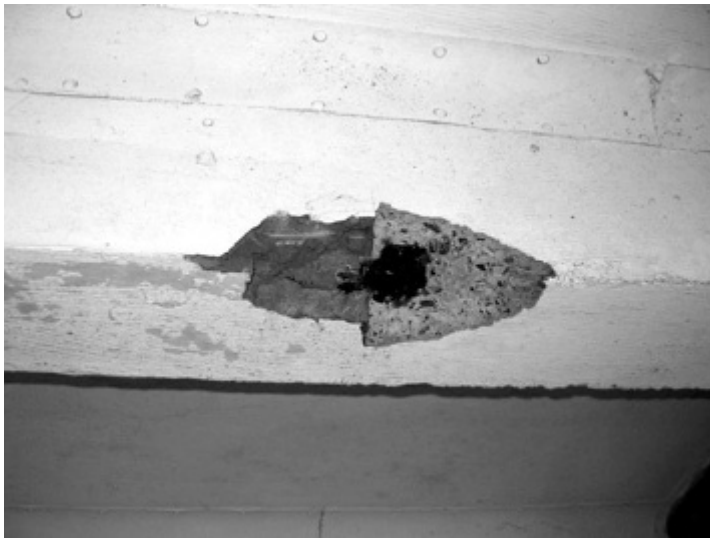
*Figure 4.4b* Incipient anode showing repair (left side) and corrosion in original concrete (from Broomfield 2007).

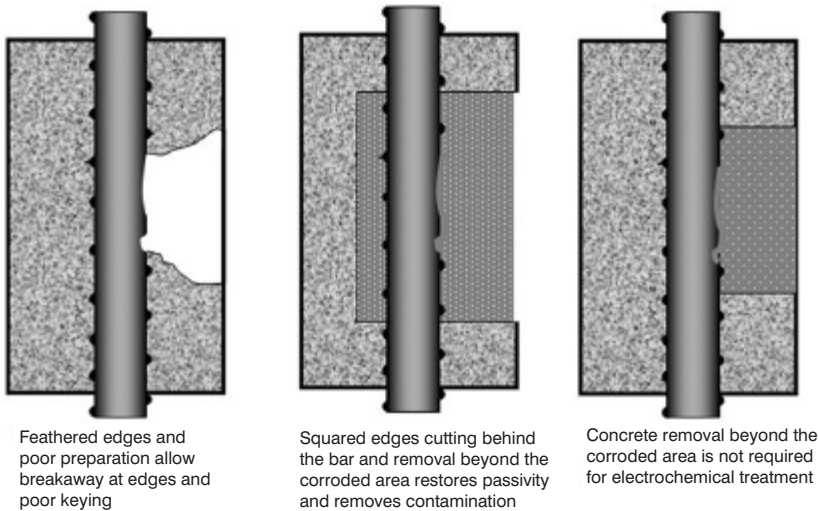
Figure 4.5 Patch repairs: bad, good and compatible with electrochemical treatments such as impressed current cathodic protection.

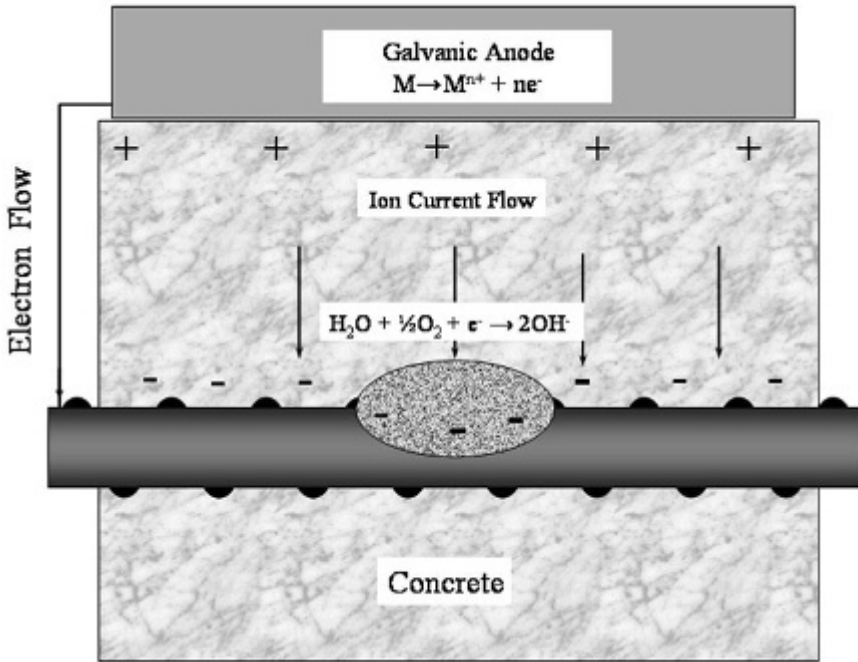
Figure 4.6 Schematic of a galvanic cathodic protection system. The steel is made cathodic by the dissolution of a suitable metal which preferentially corrodes, generating the electrons needed to sustain the cathodic reaction on the steel surface.

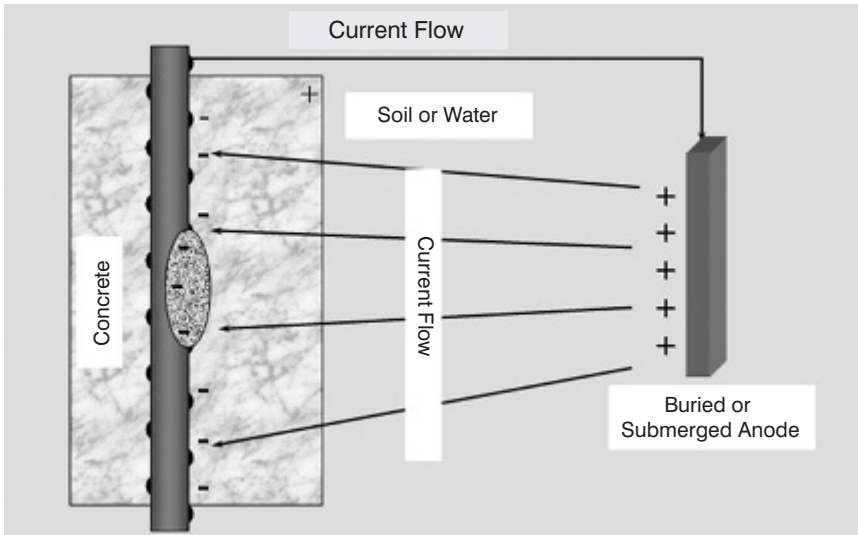
Figure 4.7 Schematic of a buried or submerged anode protecting reinforcement.

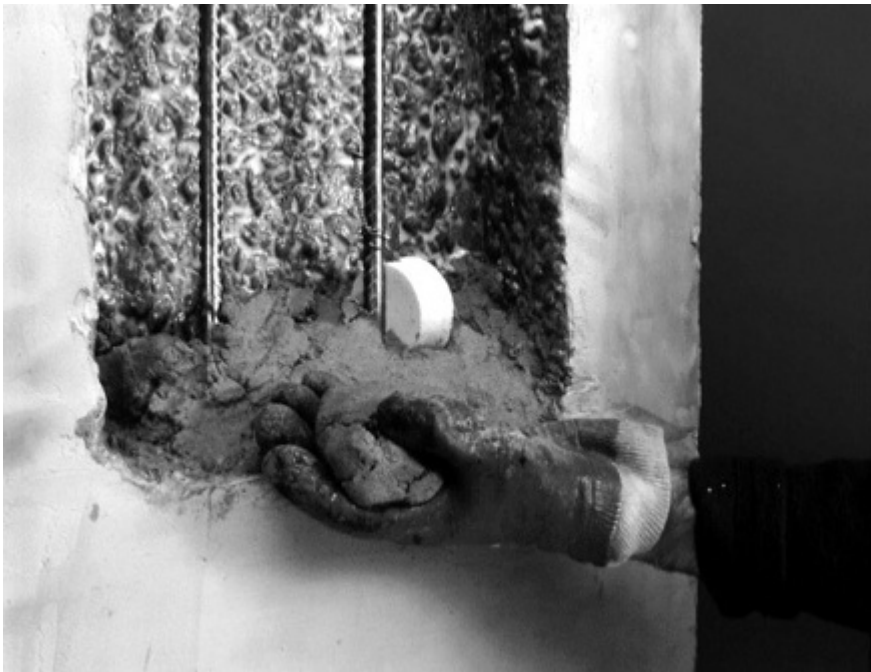
*Figure 4.9* Installation of a galvanic anode in a patch repair to prevent incipient anode induced corrosion around the repair (courtesy of Fosroc Ltd).

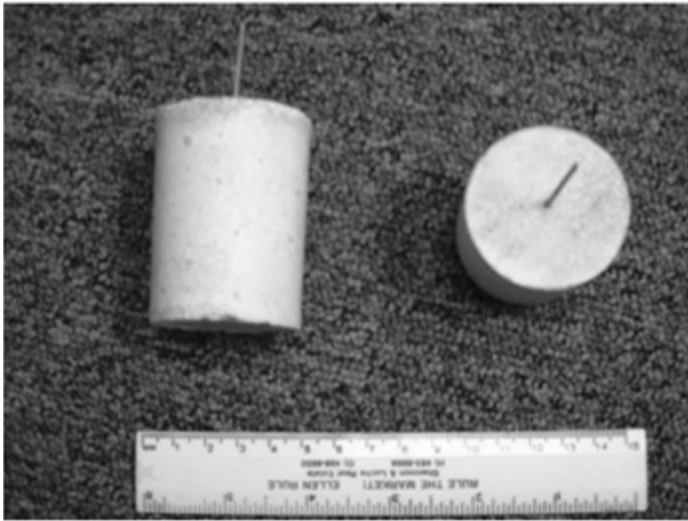
*Figure 4.10* Galvanic anodes for installation in cored holes. Anodes are linked with titanium wires to form a zone.

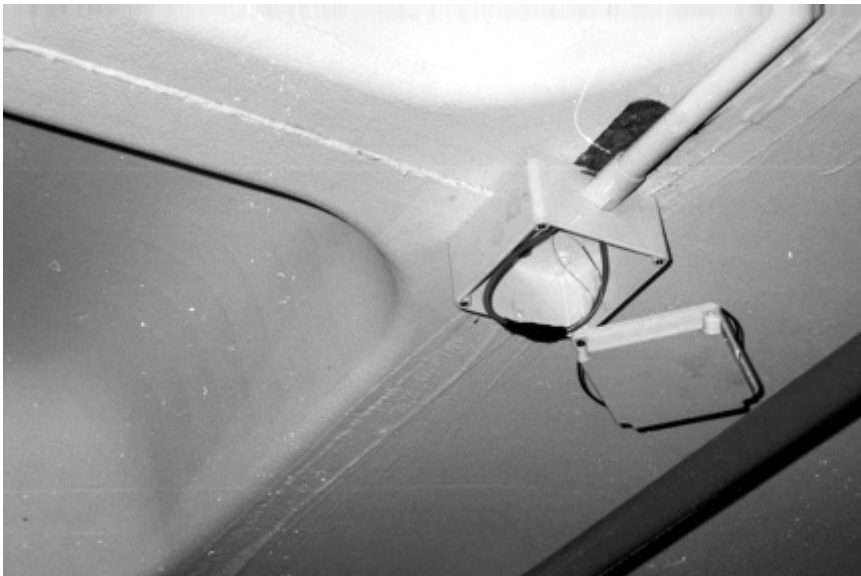
*Figure 4.15* Conductive coating anode system applied to the ‘waffle slab’ soffit of an underground car park. The primary connections are via wires and tapes embedded in the concrete and collected at a junction box.

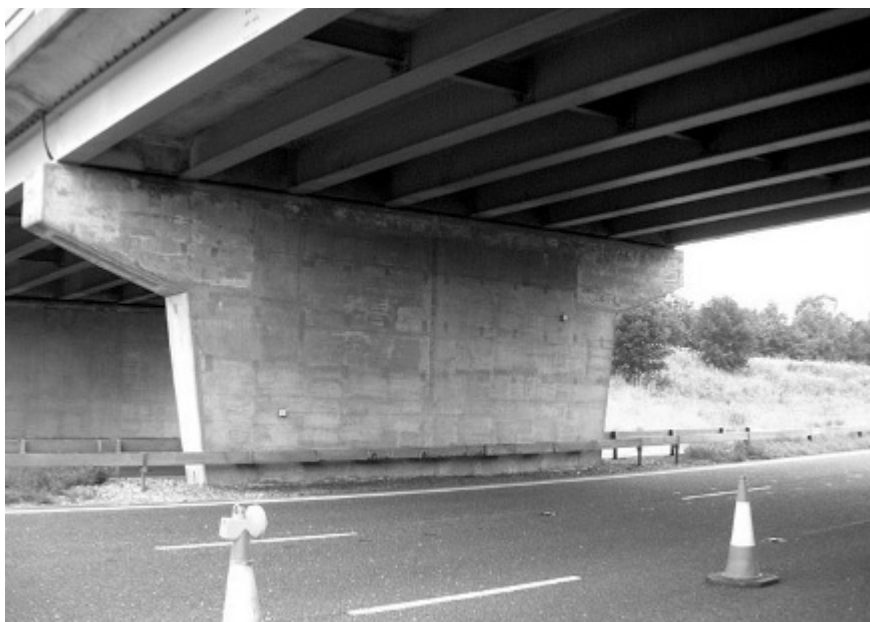
*Figure 5.1* Thermal sprayed zinc applied to the leaf piers of Golden Fleece Interchange on the M6, UK. Probe anodes are applied to the cantilevered ends, the bearing shelf and the diaphragms between the longitudinal steel where moisture run-down might degrade the life of the zinc anode.

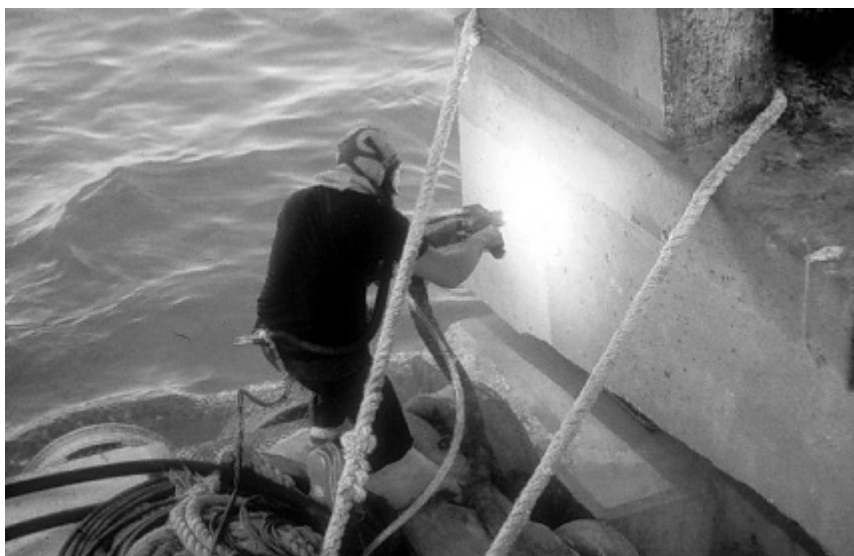
*Figure 5.2 Thermal sprayed zinc being applied to a bridge substructure in the Florida Keys (courtesy Florida DoT).*

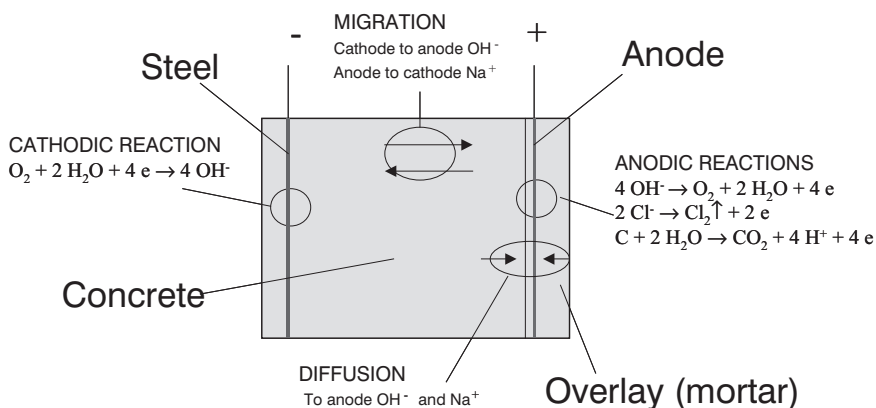
Figure 6.2 Schematic of electrode reactions, ionic migration and diffusion.

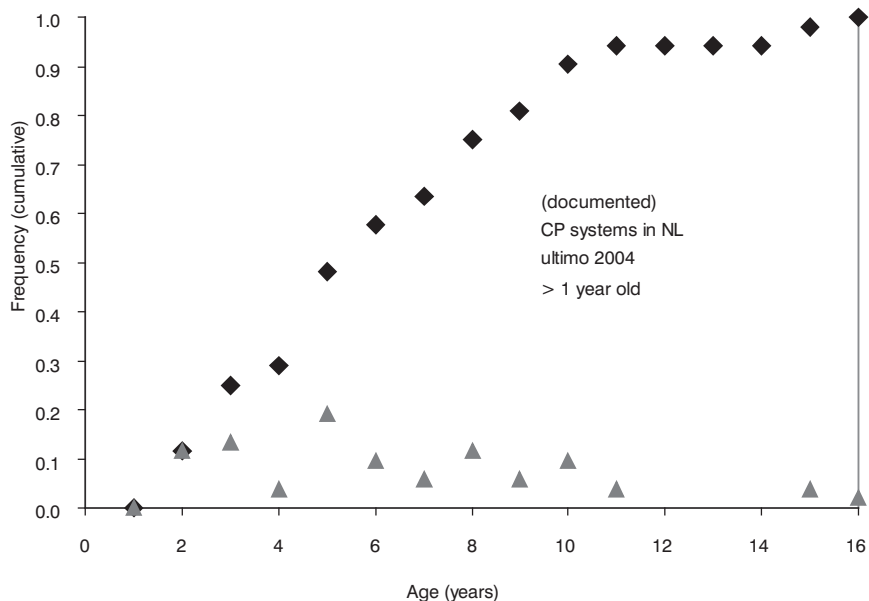
Figure 6.4 Age distribution of CP systems from inventory in The Netherlands; diamonds cumulative, triangles per year.

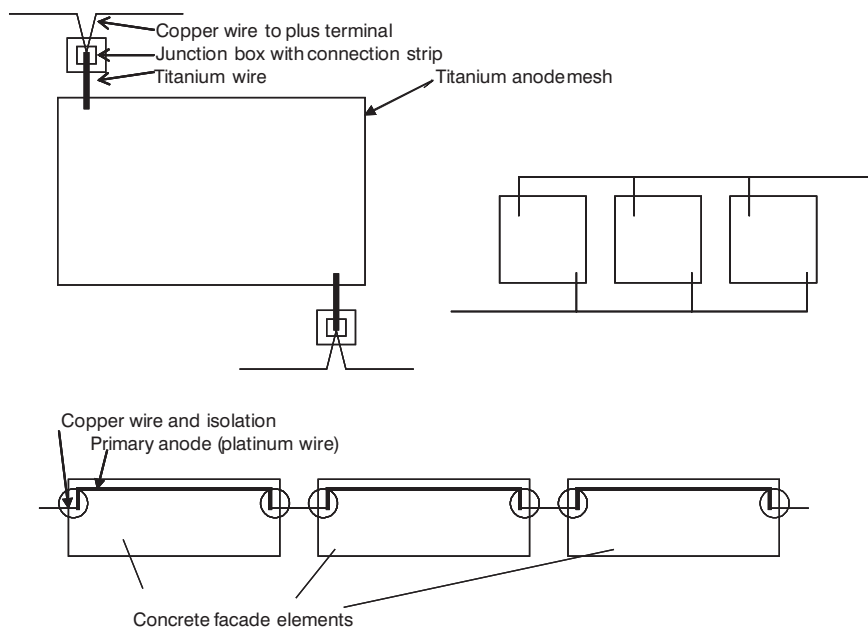
Figure 6.6 Multiple connections to individual CP system parts should be preferred (top) and series connections should be avoided (bottom).

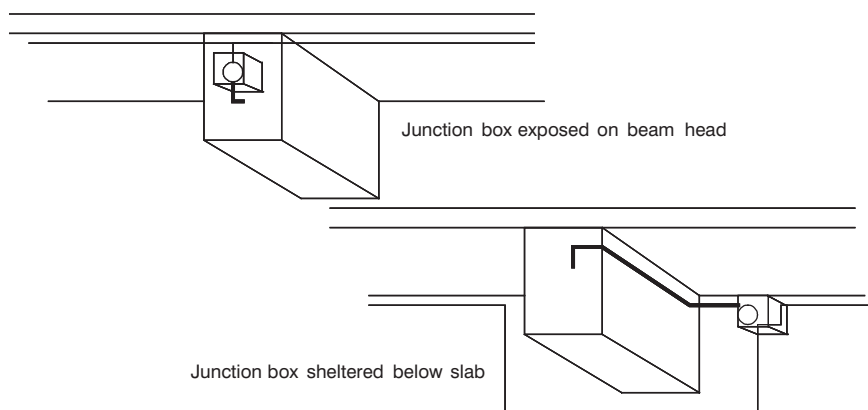
Figure 6.7 Junction boxes should be placed in a sheltered position (bottom) and not exposed, e.g. on beams heads (top).
